## GIS AND REMOTE SENSING ANALYSIS OF SAND MINING ACTIVITIES IN YENAGOA: IMPLICATIONS FOR SHORELINE STABILITY

**Abstract:** This study examines the impact of sand mining activities on the environment and host communities within Yenagoa using GIS and remote sensing techniques. Two zones, Famgbe and Obogoro communities along the Ikoli river and Tombia and Agudama-Ekpetiama communities along River Nun, were assessed in terms of environmental, infrastructural, and ground damage. Onsite observations, satellite imagery, and land use maps were used to analyze the damages caused by mining activities such as dredging and end-use activities such as filling and construction. Results reveal a direct link between the sand mining activities and damages to infrastructure, the natural environment, and shoreline migration. There is an increase in bare land and river expansion with increasing mining sites and dumpsites over the years. The study concludes that shoreline erosion has resulted from these activities, which are carried out indiscriminately in the study area without adequate licensing or monitoring. The findings of this study can serve as a basis for regulatory authorities to develop poli

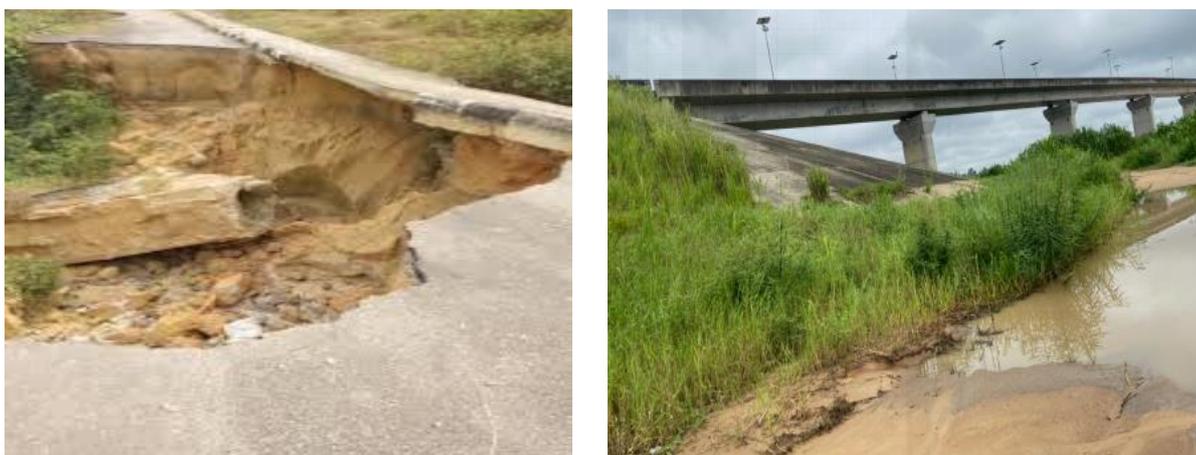
Fig. 3a. Road damage at Tombia caused by heavy Fig. 3b. ground damage near Tombia – Agudama vehicles laden with tonnes of sand Ekpetiama bridge caused by heavy vehicles laden with tonnes of sand  
From physical observations also, it was noticed that some of the mining (both manually and mechanically operated) were sited relatively close to the shoreline. It is common knowledge that the sand extraction process creates holes (usually with unprotected walls) on the bottom of the river. These unprotected walls start falling off or collapsing and this extends to the shoreline causing shoreline collapse or erosion. The Figs. 4a & 4b show this scenario as captured at Famgbe and Obogoro communities, respectively.

A study of mining sites revealed that damages to critical infrastructures (Fig. 3a). In some areas, erosion has been triggered near bridge abutments (Fig. 3b). These damages were observed to occur as moving heavy trucks loaded with tonnes of mined sand continuously exert excess weight or stress on both road infrastructure and weak grounds.

Onsite observations revealed irregular grounds and damaged roads around areas where river sand mining activities take place. These were the impressions of heavy-laden trucks used for the transportation of mined sands to end users. The activities of river sand mining are carried out indiscriminately in the study area. It was discovered from interactions with operatives that licenses were almost not necessary to carry out these activities, and even where licenses are obtained, there are no regulators visiting to monitor such activities. Shoreline erosion has resulted from these activities and to some extent shoreline migration has increased as sand mining sites and dumpsites increased over the years.

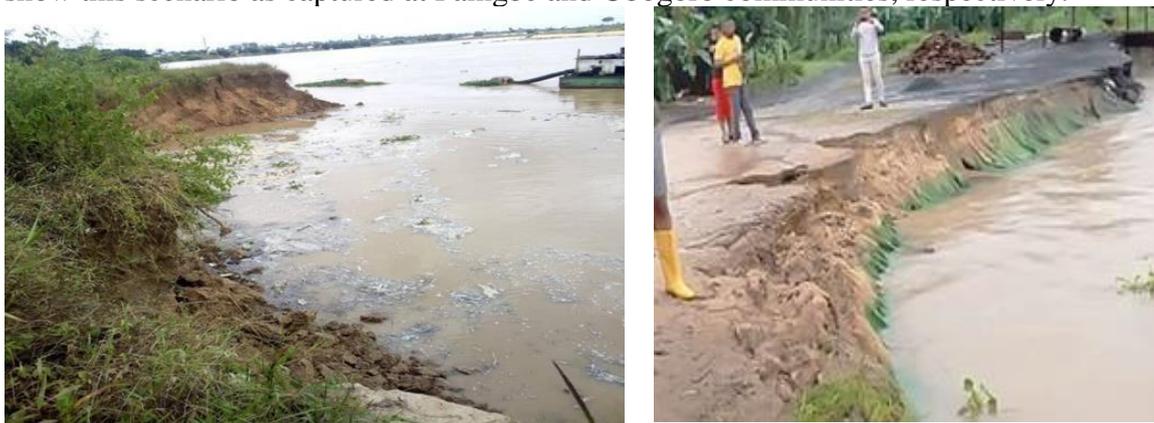
Fig. 4a. River shoreline erosion due to dredging near to Fig. 4b. River shoreline erosion due to dredging near shoreline at Famgbe community to shoreline at Obogoro community
